# [AAIB Report: Airbus A350-1041 \(G-XWBC\), tailstrike during go-around, London Heathrow Airport](#)

During an approach into London Heathrow Airport on 2 January 2022, the aircraft floated along the runway and then, during a go-around, the aircraft's tail struck the ground.

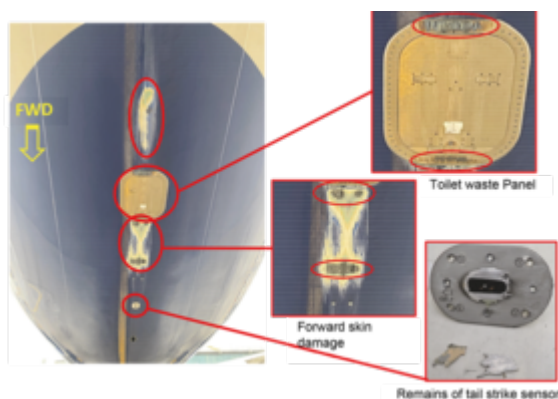
The investigation found that a go-around was initiated from low height and low speed. The aircraft had insufficient energy to climb immediately and so touched down during the go-around process. The pitch rate induced by the co-pilot caused the aircraft to reach a nose up attitude sufficient to cause a tailstrike as the aircraft touched down.
