# AAIB Report: Britten Norman 2B-26 (J8-VBI), aircraft departed runway on landing

On landing at John A. Osborne Airport in Monserrat, a Britten Norman 2B-26 (J8-VBI) veered off the right side of the runway, 29 September 2021.

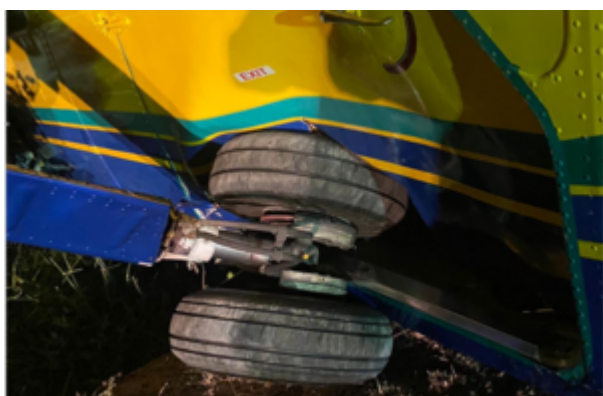
On landing, the pilot was unable to maintain directional control and reported the left brake was 'spongy'. The aircraft veered off the right side of the runway and impacted the bank of an adjacent drainage ditch. One passenger suffered minor injuries as a result.

An inspection of the braking system revealed a slight brake fluid leak from one of the pistons in the left outboard brake calliper. This would have prevented full brake pressure being achieved on the left brakes, resulting in an asymmetric braking effect. Also, difficulty in maintaining directional control was caused by use of the incorrect braking technique on landing.

The investigation identified shortcomings with the operator's manual and procedures, and with regulatory oversight. As a result, one Safety Recommendation was addressed to the Eastern Caribbean Civil Aviation Authority to ensure that the operations manual complies with the regulations.
