AAIB Report: Cirrus SR22T, insufficient engine power on takeoff

A Cirrus SR22T (2-R0R0) produced varying amounts of power on takeoff, insufficient to allow the aircraft to climb away and it contacted power lines before pitching down and striking a dual carriageway, 12 May 2019.

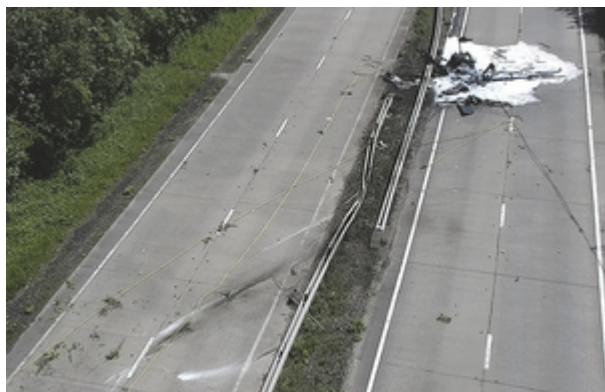
On takeoff from Abergavenny Airfield the engine of a Cirrus SR22T (2-R0R0) started to produce varying amounts of power, which the pilot and witnesses described as the engine “surging”. The power available was insufficient to allow the aircraft to climb away, and it contacted power lines before pitching down and striking a dual carriageway. The aircraft came to rest inverted and was quickly consumed by fire. All three occupants were helped to escape by a passing motorist and suffered only minor injuries.

The loss of engine power was probably caused by too much fuel being delivered to the cylinders. Due to the significant damage to the aircraft and parts of the engine, the investigation was unable to determine the cause of the over-fuelling because many components of the fuel system as well as the data recorder were not located or were destroyed in the post-impact fire.
