[AAIB Report: DA 40 NG \(G-CTSB\), Aircraft stalled and struck the ground shortly after takeoff.](#)

On takeoff from Cranfield Airport an aircraft loaded with five containers of de-icing fluid stalled and struck the ground, 12 December 2020.

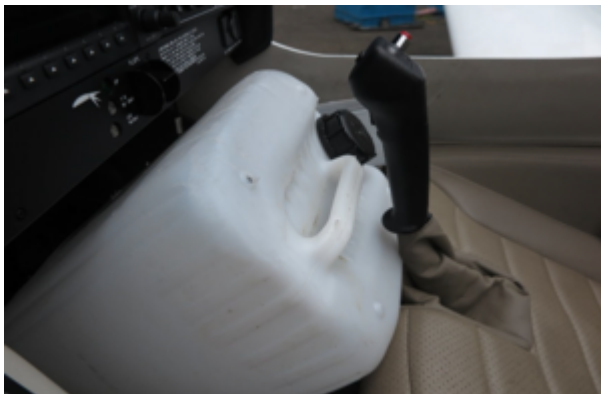
The aircraft, a DA 40 NG (G-CTSB), stalled and struck the ground shortly after takeoff from a height of about 100-200 ft. The pilot survived but sustained serious injuries.

The aircraft had been loaded with five containers of de-icing fluid, contrary to the approved training organisation's prohibition on the carriage of cargo and dangerous goods. One container, loaded in the front right footwell close to the flying controls, limited the forward movement of the control stick. The aircraft was near its maximum permitted takeoff weight and aft centre of gravity limit when it departed. This, together with the limited control authority available, caused the accident.

One Safety Recommendation is made regarding the use of recording facilities on digital flight instrument systems.
