# [AAIB Report: ERJ 190-200 LR, emergency evacuation](#)

News story

Published 17 September 2020

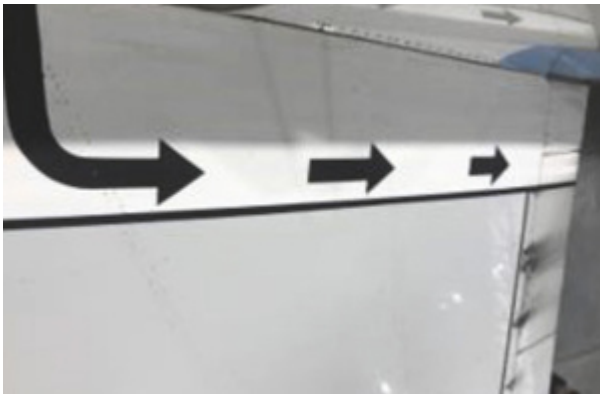
The flight crew of an ERJ 190-200 LR (G-FBEJ) detected an unusual odour and observed smoke entering the cockpit and cabin. An emergency evacuation was initiated during which passengers evacuating via the overwing exits reported being unsure of how to get down to the ground. Several re-entered the cabin and left via alternative exits, 28 February 2019.

On 28 February 2019, as the thrust levers of an ERJ 190-200 LR (G-FBEJ) were advanced for takeoff from Exeter Airport, the flight crew detected an unusual odour and observed smoke entering the cockpit. The thrust levers were moved to the idle position and parking brake applied. The cabin crew subsequently reported that there were smoke and fumes in the cabin and the commander initiated an emergency evacuation.

During the evacuation, passengers evacuating via the overwing exits reported being unsure of how to get down from the wing to the ground and several re-entered the cabin and exited via one of the escape slides. The smoke and fumes were attributed to an incorrectly performed engine compressor wash procedure.

As a result of the findings of this investigation, the European Union Aviation Safety Agency (EASA) has undertaken two safety actions relating to the certification requirements for overwing emergency exits. The operator has also undertaken several safety actions relating to passenger safety briefings, processes for maintenance planning, engineer training, competency and welfare and monitoring of ground equipment. Four Safety Recommendations are made relating to the certification requirements for overwing exit markings and the height requirement for overwing exits to be equipped with an assisted means of escape.
