# [AAIB Report: G-BOSN, Engine fire shortly after lifted to hover, Hedsor, Buckinghamshire, 2 March 2021](#)

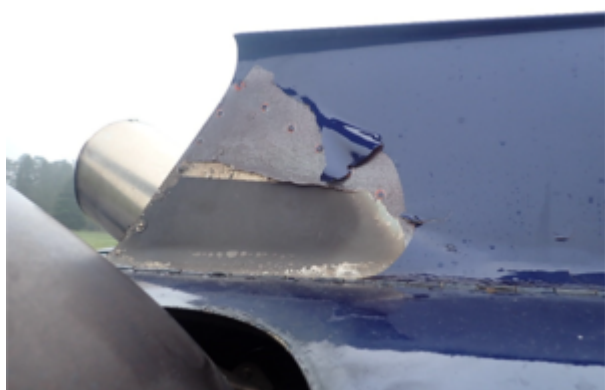
Whilst hovering, smoke was observed coming from the engine exhaust of an Airbus Helicopters AS355 F1. After landing a fire was also observed and a fire warning subsequently illuminated, leading the pilot to activate the fire extinguishing system, 2 March 2021.
