AAIB Report: G-DEJH, Structural failure of glider tail assembly, Cross Fell, Pennines, Cumbria

News story

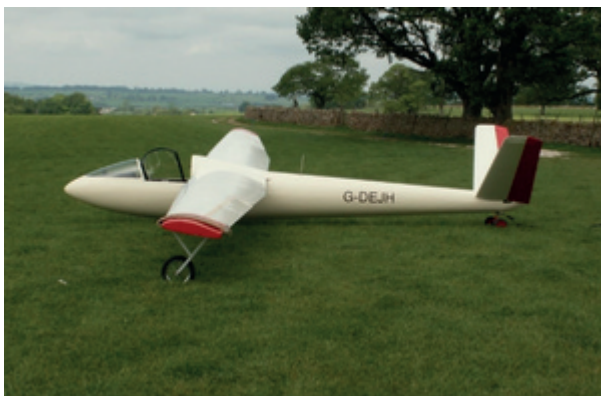
A pilot was flying low behind the ridge at Cross Fell in the Pennines when the tail section of the glider began to oscillate rapidly and broke away from the glider. The glider, an SB-5E, pitched nose down and was heavily disrupted when it struck the surface, 7 Aug 2019.

The cause of the failure was flutter (an oscillation of a structure under the interaction of aerodynamic and aeroelastic forces) which was driven by the ruddervators. It was likely to have occurred when the glider was flying between the rough air speed limit and the maximum operating speed.

A number of safety actions have been taken to improve the supervision of young glider pilots, maintenance of training records and the introduction of a national syllabus for hill soaring (ridge flying).
