AAIB Report: G-MPSB, Heavy landing during simulated single engine training, North Weald Airfield, Essex

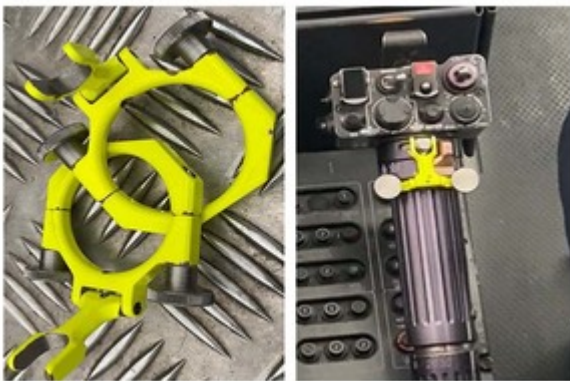
On 12 March 2021, during the demonstration of an engine failure after takeoff emergency procedure, the commander of a MBB-BK 117 helicopter reduced one of the engine's throttle to idle. When the throttle setting was later increased, the engine did not respond. Takeoff was rejected and a firm landing executed.

The engine failure was simulated by the commander reducing Engine No 1's throttle to idle. Shortly afterwards the commander increased the throttle setting, but Engine No 1 did not respond. During attempts to resolve the problem, the throttle setting for Engine No 2 was inadvertently reduced, resulting in insufficient power being available for continued safe flight. The commander rejected the takeoff and executed a firm landing within the airfield boundary.

The subsequent engineering investigation did not find any evidence of malfunction in the engine control systems. Engine No 1 probably did not respond because the rotor rpm droop compensation had been inadvertently trimmed in the wrong direction.

This incident reinforces the benefit of using flight simulators wherever possible to de-risk training, thus avoiding the requirement for live emergency training in the helicopter. Safety action has been taken by the helicopter operator as a result of this investigation.
