AAIB Report: Hawker Sea Fury T Mk 20 (G-RNHF), Forced landing due to loss of engine power, near RNAS Yeovilton, Somerset

News story

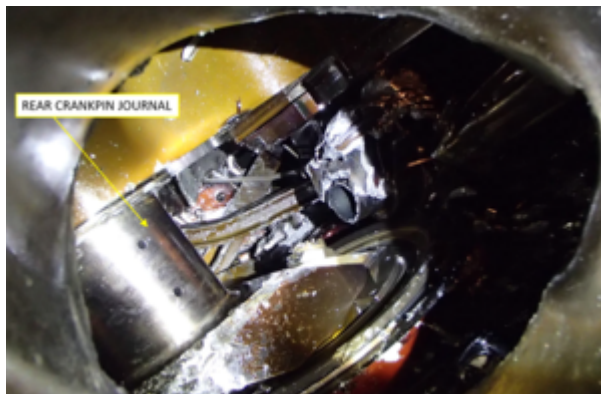
A Hawker Sea Fury T Mk 20 (G-RNHF), was being positioned for a landing following a low engine oil pressure indication. As the aircraft began the base turn, the engine seized suddenly and the pilot had to make a forced landing, 28 April 2021.

The aircraft was being positioned for a landing on Runway 04 at RNAS Yeovilton following a low engine oil pressure indication. As the aircraft began the base turn, the engine seized suddenly and the pilot was unable to feather the propeller. Due to the extremely high rate of descent required to maintain speed it was not possible to reach the runway. The aircraft struck the ground approximately 0.5 nm from the runway threshold. The aircraft was destroyed but both occupants were able to extract themselves from the cockpit.

The investigation found that the engine's rear crankpin bearing had overheated, leading to extensive damage within the rear crankcase and causing the engine to seize. Due to the severe damage to the engine, the cause of the rear crankpin bearing becoming overheated was not established
