# AAIB Report: Hawker Sea Fury T Mk 20 (G-RNHF), Forced landing due to loss of engine power, near RNAS Yeovilton, Somerset

News story

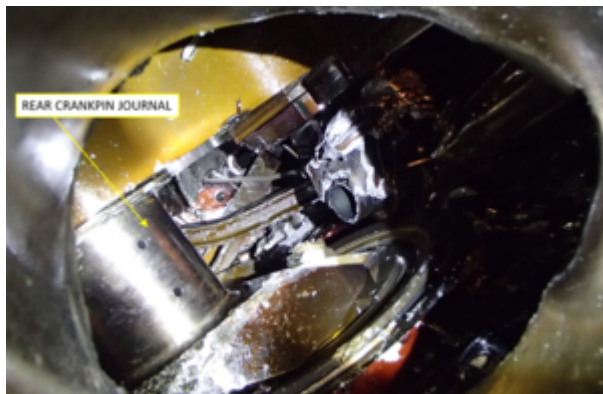
A Hawker Sea Fury T Mk 20 (G-RNHF), was being positioned for a landing following a low engine oil pressure indication. As the aircraft began the base turn, the engine seized suddenly and the pilot had to make a forced landing, 28 April 2021.

The aircraft was being positioned for a landing on Runway 04 at RNAS Yeovilton following a low engine oil pressure indication. As the aircraft began the base turn, the engine seized suddenly and the pilot was unable to feather the propeller. Due to the extremely high rate of descent required to maintain speed it was not possible to reach the runway. The aircraft struck the ground approximately 0.5 nm from the runway threshold. The aircraft was destroyed but both occupants were able to extract themselves from the cockpit.

The investigation found that the engine's rear crankpin bearing had overheated, leading to extensive damage within the rear crankcase and causing the engine to seize. Due to the severe damage to the engine, the cause of the rear crankpin bearing becoming overheated was not established
