# AAIB Report: Modified Piper PA-46-350P (G-HYZA), Loss of power from hydrogen fuel cells to the electrical propulsion system while undertaking an experimental flight.

News story

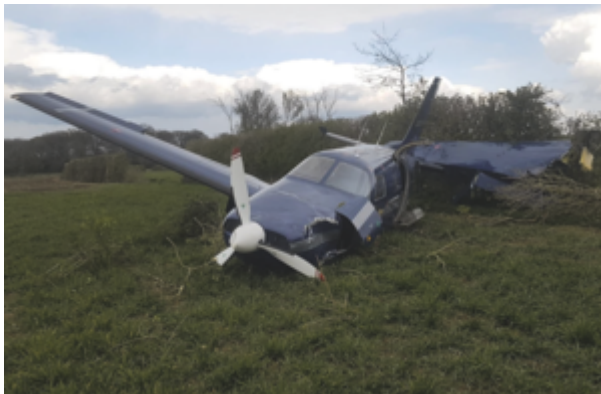
During an experimental flight near Cranfield Airport of a modified Piper PA-46-350P (G-HYZA), an electrically powered aircraft with electrical power from hydrogen fuel cells, suffered a loss of power to the electrical motors. This meant a forced landing was carried out, which severely damaged the aircraft, the crew were unharmed.

The loss of power occurred during an interruption of the power supply when, as part of the test procedure, the battery was selected to OFF with the intention of leaving the electrical motors solely powered by the hydrogen fuel cell. During this interruption, the windmilling propeller on the aircraft generated voltage that was high enough to operate the inverter protection system. This then locked out the power to the motors and the pilot and observer were unable to reset the system and restore electrical power.
