AAIB Report: N967FE, Abnormal runway contact on landing, Terrance B Lettsome International Airport, British Virgin Islands

The aircraft, a Cessna C208B Super Cargomaster (N967FE) made a hard landing two thirds of the way along the runway and left the paved surface during the landing roll, 23 Sept 2020.

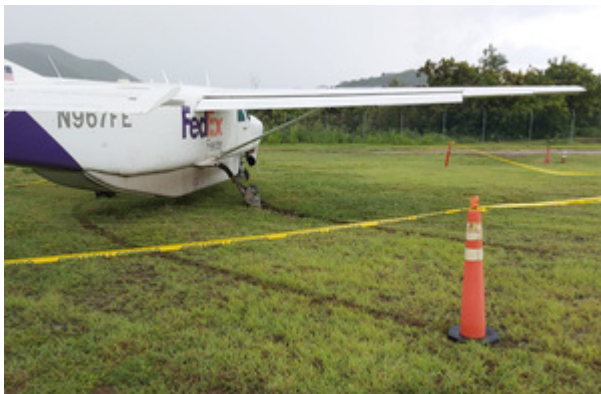
The pilot was operating a cargo flight from San Juan, Puerto Rico to Tortola, British Virgin Islands. He discontinued the first approach due to poor weather. Following the second approach the aircraft made a hard landing that was 795 m beyond the threshold of the 1,206m runway. During the landing roll the aircraft veered off the runway damaging the wheels, landing gear and baggage pod.

Data from the aircraft showed that the approach did not meet the operator's stable approach criteria. It also showed that the engine was running below the normal flight idle speed during the last few moments of the flight. Examination and testing found no evidence of anomalies with the engine. It was not possible to determine why the engine was operating below the normal idle speed whilst in flight.

It is likely that the pilot was experiencing high workload due to the unstable approach and poor weather and this may have limited his ability to deal with the situation. The operator intends to update its operations manual to state explicitly the altitude by which stable approach criteria must be achieved for all types of approach.
