# [AAIB Report: Standard Cirrus 75, fatal accident](#)

During ground roll, the tailplane detached from the Standard Cirrus 75 (G-DDGX). Signals for the takeoff to be aborted did not reach either pilot. The glider became airborne, climbed rapidly, before descending steeply and striking the ground, 27 July 2019.

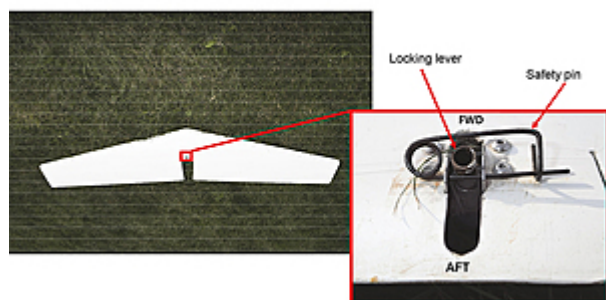
The investigation determined that the tailplane had not been correctly attached when the glider was rigged and this was not detected prior to the flight. The precise manner in which the tailplane had been mis-rigged could not be determined.

Two Safety Recommendations are made relating to communication for glider launching and detecting incorrect alignment of tailplane locking features. In addition, the gliding club has undertaken several safety actions regarding launch signalling and detection of incorrect tailplane locking on other Standard Cirrus gliders.
