# Buffer stop collision at Kirkby station

Investigation into a buffer stop collision at Kirkby station, Merseyside, 13 March 2021.

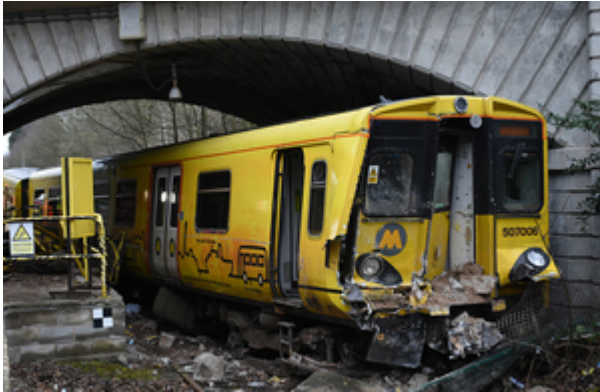
Derailed train after the collision

At around 18:53 hrs on 13 March 2021, the 18:35 hrs service from Liverpool Central to Kirkby struck the buffers located at the end of the Merseyrail Northern line platform at Kirkby station. The train approached the station at around 42 mph (68 km/h), before an emergency brake application was made, slowing the train before it hit the buffers. The train then derailed and collided with a platform extension which links the Northern line platform to the adjoining Kirkby branch line platform. The derailed train came to a stop under a bridge and clear of the branch line, which was not occupied by a train at the time.

Twelve people reported suffering minor injuries as a result of the accident, and significant damage was caused to the train and to railway infrastructure.
