# HyD's response to media enquiries on water leakage at basement of Passenger Clearance Building of Hong Kong-Zhuhai-Macao Bridge Hong Kong Port (with photos)

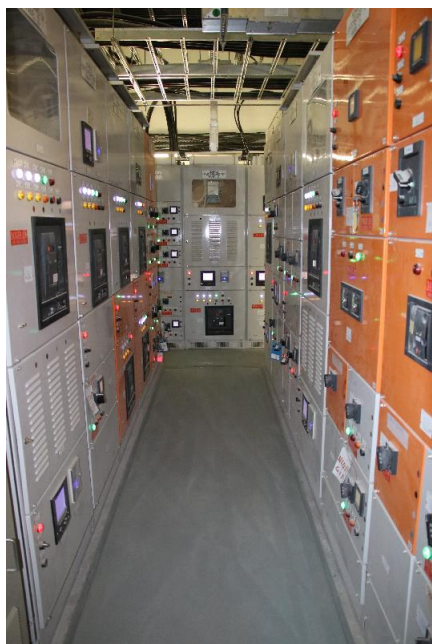
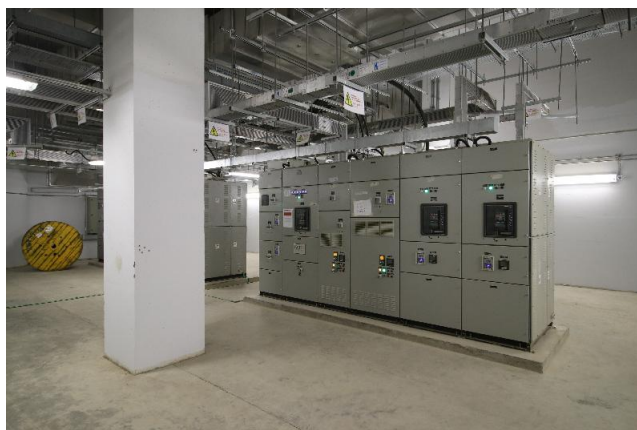
Soon after the contractor and the HyD's resident site staff discovered the leakage problem at the PCB in early 2018, they had swiftly followed up the issue and arranged rectification works. According to the records kept by the resident site staff of the consultant appointed by the HyD, after the structural and fitting-out works of the PCB were completed, some underground cable ducts had not been sealed up timely after cable installation, thus leading to leakage of rainwater into the basement via these ducts on April 15, 2018. The contractor had subsequently rectified the problem by properly sealing up the relevant ducts. After recent rainstorms, including the amber rainstorm yesterday (July 2), the HyD has not observed any noticeable water leakage during site inspections at the basement of the PCB.

For the present conditions inside the PCB basement, please refer to the photographs attached.
