Pothole repairs – Hillside Drive #dundeewestend

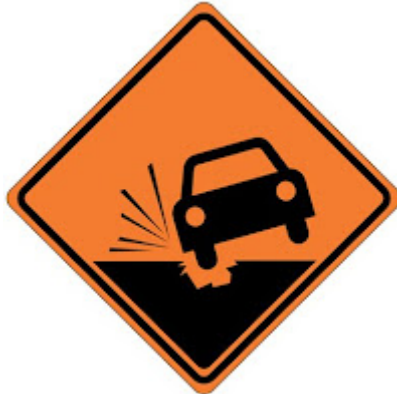
Further to my recent update about residents' concerns about a poor quality of pothole repair in Dunmore Gardens, I have also had similar complaints in Hillside Drive.

'Similar to Dunmore Gardens, the repairs were inspected and I note that these pothole repairs do not have a film of bond coat painted on the existing road surface prior to filling which will affect the long term adhesion and therefore durability, and I will take this matter up internally.

The material specified for use in carriageway pothole repairs is chosen to suit a depth of 40mm, or greater. By trying to carry out a repair to a defect of insufficient depth the material sits proud and frets at the edges as the aggregate within the material cannot fit in the depression once compacted. If we use smaller aggregate then there is insufficient strength in the material to resist expected vehicular loading.
