# Pothole repairs – Hillside Drive #dundeewestend

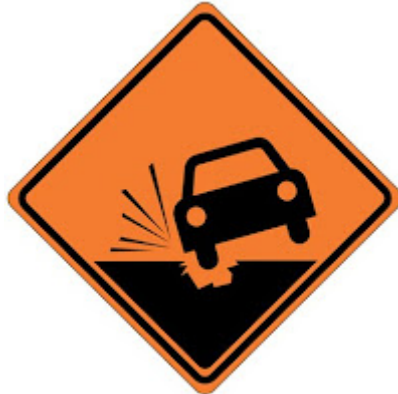
Further to my recent update about residents' concerns about a poor quality of pothole repair in Dunmore Gardens, I have also had similar complaints in Hillside Drive.

**'Similar to Dunmore Gardens, the repairs were inspected and I note that these pothole repairs do not have a film of bond coat painted on the existing road surface prior to filling which will affect the long term adhesion and therefore durability, and I will take this matter up internally.**

The material specified for use in carriageway pothole repairs is chosen to suit a depth of 40mm, or greater. By trying to carry out a repair to a defect of insufficient depth the material sits proud and fretts at the edges as the aggregate within the material cannot fit in the depression once compacted. If we use smaller aggregate then there is insufficient strength in the material to resist expected vehicular loading.

Hillside Drive, Place and the east/west leg of Hillside Road , when assessed in comparison to other adopted residential streets throughout the city, are in fair condition and therefore a proposed timescale for resurfacing in year 2020/21 is in my opinion reasonable. I can advise that there are 215 streets which have been prioritised in advance of these streets.'
