[RAIB report 07/2020: Freight train derailment at Willesden High Level Junction](#)

RAIB has today released its report into a freight train derailment at Willesden High Level Junction, north-west London, 6 May 2019.

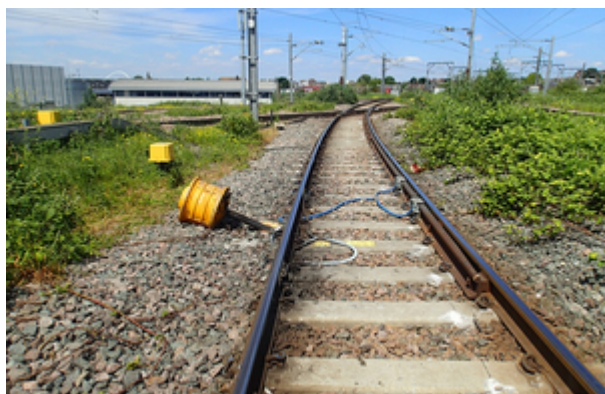
The derailment marks on the approach to Willesden High Level Junction (after track restoration)
