[Report 02/2021: Freight train derailment at Eastleigh](#)

Press release

RAIB has today released its report into a freight train derailment at Eastleigh, Hampshire, 28 January 2020.

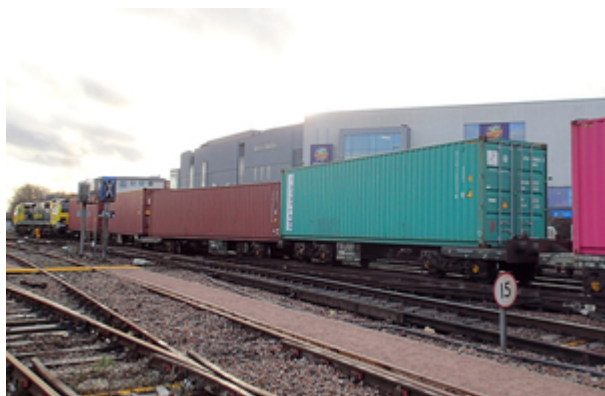
The derailed wagons

At about 11:32 hrs on Tuesday 28 January 2020, a freight train derailed while travelling over a set of points at Eastleigh West Junction, immediately south of Eastleigh station. The locomotive hauling the train ran derailed for about 35 metres, causing significant damage to the infrastructure. Four wagons subsequently derailed on the damaged track. Nobody was injured in the accident.

Some of the fastenings that hold the rails to the concrete bearers that support them had fractured, prior to the passage of the train. This allowed one of the rails to move outwards under the train, breaking further fastenings and causing the locomotive's wheels to drop inside the rail, as it moved further outwards. The design of these fastenings made them more prone

to this type of failure when subjected to high lateral forces, which were present at these points due to the track geometry at the site and the curving characteristics of the locomotive. The local track maintenance team had not identified any relevant faults prior to the derailment as the fastenings had fractured below the surface of the concrete bearer and these failures were not apparent during visual inspections. Despite previous faults of a similar nature elsewhere, Network Rail had not developed an effective inspection regime to detect such failures. Measurements of the track geometry of this set of points had also not detected any indication of deterioration in the track fastening system.

RAIB has identified two recommendations and two learning points as a result of the investigation. The recommendations are both addressed to Network Rail. The first regards the development of a management strategy to address the ongoing risk of failure of track fastening systems of the type involved in the derailment. The second concerns a review of how Network Rail measures dynamic track gauge on lines that are not monitored by a track measurement train.
