Report 04/2021: Signal passed at danger and subsequent near miss, Chalfont & Latimer station

RAIB has today released its report into a signal passed at danger and subsequent near miss, Chalfont & Latimer station, 21 June 2020.

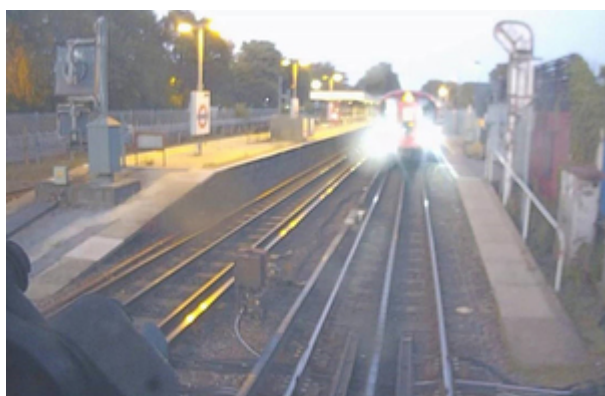
Forward-facing CCTV image from southbound train, showing stopping positions of the trains involved (image courtesy of Chiltern Railways)

The Chiltern Railways train stopped about 23 metres before reaching the other train, which was stationary. There were no reported injuries, but there was minor damage to signalling equipment and a set of points.
