[Report 12/2020: Derailment of a freight train near Wanstead Park](#)

RAIB has today released its report into the derailment of a freight train near Wanstead Park, London, 23 January 2020.

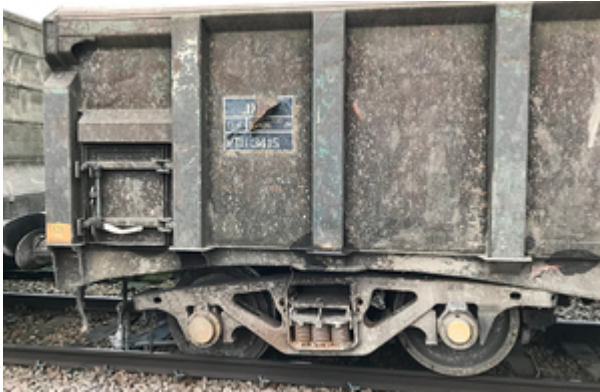
The derailed wagon

Shortly before 06:00 hrs on Thursday 23 January 2020, a wagon in the rear half of a heavily loaded freight train derailed on a small radius curve as it crossed a bridge in east London. The forces from the train caused the rails on the bridge, which were attached to large longitudinal timbers, to spread apart. Two adjacent wheelsets from different wagons derailed, but one wheelset re-railed itself after travelling a short distance. The other wheelset remained derailed as the train continued for 2.5 miles (4.1 km) before stopping, and this caused significant track damage. Wagons positioned behind the derailed wagons remained on the track.

Track where the rails are supported on longitudinal timbers is subject to special inspections by staff who have received additional training to undertake this role. RAIB found that the condition of the timbers at the point of derailment had severely deteriorated because of rot, but this was

concealed by their superficially good exterior condition. The inspection method and tools used by Network Rail staff were not sufficient to detect the poor internal condition of the timber.

One wagon in the train exerted sufficient force on the weakened track support to force the rails apart and cause the wagon to derail. Examination of the first wagon to derail and its maintenance records indicated that it had experienced unusually rapid wheel wear over several years. It is possible that this meant it was imposing higher than normal lateral forces on the track and that this is related to a defect which affected the way the bogie was able to rotate.

RAIB has made one recommendation to Network Rail regarding improvements in the provision of track recording vehicle data to track maintenance staff, and one recommendation to the wagon owner concerning the monitoring of maintenance activities to reduce the risk of defective rail vehicles entering service. It has identified three learning points covering the management of longitudinal timber systems and loading activities in freight loading terminals.
