Report 13/2020: Collision and derailment at Neville Hill

Press release

RAIB has today released its report into the collision and derailment at Neville Hill, 13 November 2019.

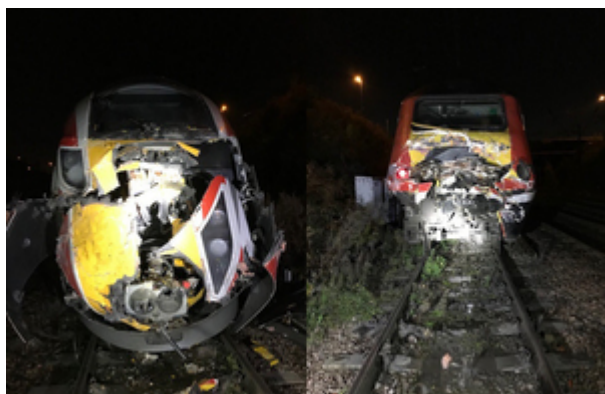
The class 800 train (left) and HST set (right) involved in the accident (images courtesy of Network Rail)

At 21:41 hrs on 13 November 2019, an empty LNER Intercity Express Train, approaching the maintenance depot at Neville Hill in Leeds, caught up and collided with the rear of a LNER High Speed Train moving into the depot. The leading train was travelling at around 5 mph (8 km/h) and the colliding train at around 15 mph (24 km/h). No one was injured in the accident, but the trailing bogie of the second and third vehicles and the trailing wheelset of the fourth vehicle of the Intercity Express Train derailed to the right, by up to 1.25 metres.

The derailment occurred because the design of the Intercity Express Train is susceptible to derailment in low speed collisions. This susceptibility is related to the use of high-strength couplers with large freedoms of movement in pitch and yaw. These features were part of the train's design. However, the impact of these features on the train's resistance to derailment and lateral displacement in low speed collisions, was not considered by the train's designers.
