# Wrong side signalling failure at Wingfield

Wrong side signalling failure at Wingfield, Derbyshire, 26 October 2022.

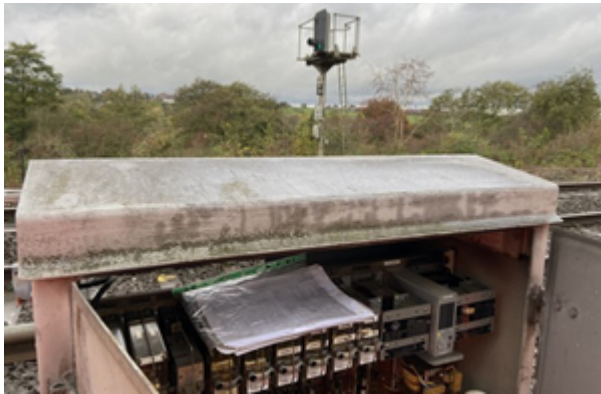
Signal DY586 and its signalling location cabinet

On the morning of 26 October 2022, a signal at Wingfield in Derbyshire (which had been disconnected and reconnected the previous night as part of planned track maintenance work) was returned to service with a fault. This fault caused a wrong side failure, with the signal's red and yellow aspects being displayed incorrectly.
