[AAIB Report: Boeing 737-408 \(G-JMCY\), heavy landing resulting in significant structural damage, Exeter Airport](#)

During an approach at Exeter Airport, a Boeing 737-408 (G-JMCY) became unstable and suffered a heavy landing which resulted in significant structural damage.

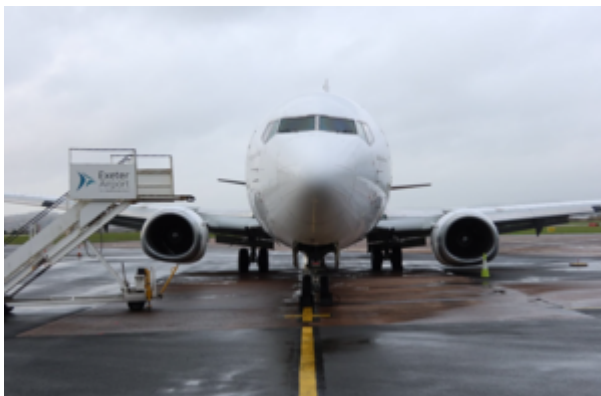
During an approach at Exeter Airport, the aircraft became unstable after the point where the crew had declared the approach stable and continued. During the final 500 ft the rate of descent exceeded the required 500 ft stable approach criteria on four occasions. All bar the first of these excursions were accompanied by GPWS "SINK RATE" alert. The subsequent hard landing resulted in extensive damage to the aircraft. There were no injuries.

The operator has taken safety action to reinforce its operating procedures with regards to the criteria for a stable approach.
