# AAIB Report: MD 900 (G-LNDN), Avionics abnormalities in flight

Various electrical system faults due to water ingress, in flight between Royal London Hospital and RAF Northolt, Greater London, 25 July 2021.

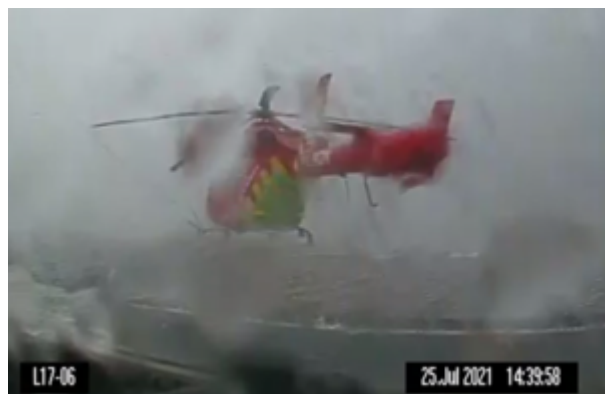
During a flight from the Royal London Hospital to RAF Northolt, a MD 900 (G-LNDN) suffered a series of electrical system faults. The electrical failures were the result of water ingress, 25 July 2021.

The investigation found that the electrical failures were the result of water ingress from the right engine bay onto electronic components located in the rear fuselage area.
