AAIB Report: Mooney M20K, Baggage door detachment in flight

The baggage door of a Mooney M20K aircraft detached in flight causing the pilot to declare a MAYDAY. The pilot was able to land safely without injury, 30 May 2020.

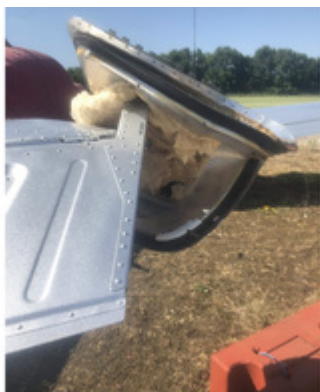
A Mooney M20K aircraft (G-OSUS) had been flying for approximately 15 minutes and was in level flight when the baggage door opened and detached. It struck the right tailplane and remained wrapped round the leading edge near its tip. This caused the pilot control difficulties and increased drag. The pilot declared a MAYDAY and made a successful emergency landing at Membury Airfield.

The investigation found the safety clip for the internal emergency operating handle of the baggage door was not correctly installed, so instead of holding the handle closed it held it in a slightly open position. During the flight, it seems most likely that this handle moved sufficiently towards the open position to disengage the shoot bolts from the door frame allowing the door to open. It could not be determined when the safety clip was incorrectly installed or why it had not been noticed.
