Collision at Burgess Drove user worked level crossing

Preliminary examination into a collision at Burgess Drove user worked crossing, near Waterbeach, Cambridgeshire, 9 August 2021.

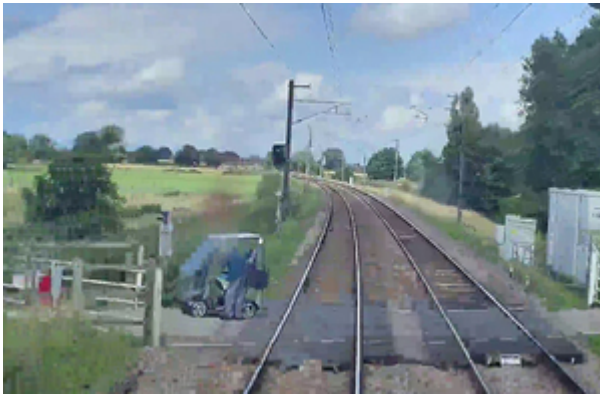
Forward facing CCTV image showing position of the mobility scooter and user as the train approached (courtesy of Abellio Greater Anglia)

At around 14:33 hrs on 9 August 2021, a train operated by Greater Anglia passed over the level crossing at Burgess Drove, near Waterbeach, and struck the rear part of a mobility scooter which was inside the crossing area, adjacent to the down side gate. The mobility scooter user was near to the scooter when the collision occurred, but was uninjured. The scooter sustained minor damage.

RAIB was notified of the collision by Network Rail and gathered evidence from the railway industry to carry out a preliminary examination into the circumstances of the accident. RAIB has concluded that the accident occurred because the mobility scooter user was not able to complete their crossing of the railway in the time available between the beginning of the warnings of the train's approach, provided by a red light and an audible alarm at the crossing, and the arrival of the train. The RAIB has estimated that, for reasons explained below, the user would have needed approximately 100 seconds from starting to open the first gate until fully closing the second. However, the warning of an approaching train would occur only approximately 40 seconds before its arrival at the crossing.

RAIB found that user at Burgess Drove was unlikely to have been physically fit enough to make the four separate crossings on foot required to operate the user worked crossing in the way required of a vehicular user and this was the likely reason for them using the crossing in the same manner as a pedestrian. This would have seen them first opening the approach gate, moving the scooter forwards, closing this first gate and then moving forwards over
