# Company fined after worker crushed by roller

Former manufacturing company Betafence Ltd was sentenced for safety breaches after worker was crushed by a wire drawing roller.

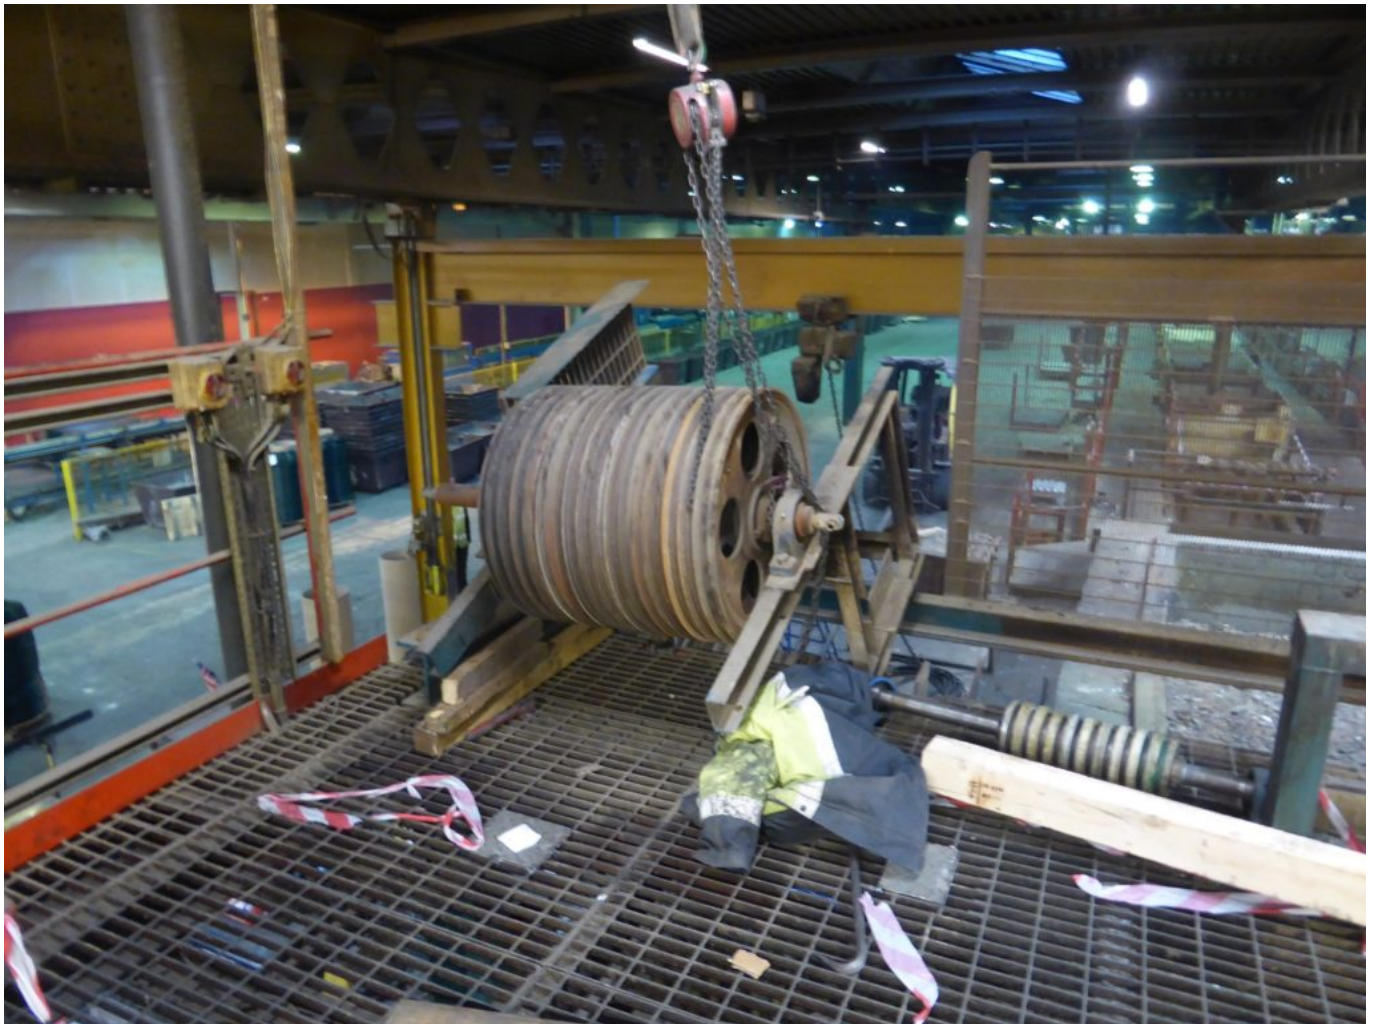
Sheffield Magistrates' court heard how on 8 February 2017, the worker was reconfiguring some wire drawing equipment which had previously been used to apply a zinc coating to wire at a site on Shepcote Lane in Sheffield. The worker slid the roller in the carriage towards the edge of the mezzanine. He had to lie on his stomach on the mezzanine to access bolts connecting a roller weighing approximately 500kg which was above his head and quench unit below.

He unbolted the two parts, with a colleague using a fork lift truck to hold the weight of the quench unit. As they separated, the metal carriage which held the roller tilted forward. The roller landed on his lower back. He suffered fractures of his pelvis and lumbar region of his spine.

The roller was able to tilt as it was on wheels, which had aligned with slots cut into the track. Protruding arms of the carriage struck the mezzanine floor first, preventing the full weight of the roller from crushing him.

"A suitable and sufficient risk assessment would have identified that uncontrolled movement of the roller or wiping unit could have presented a crushing risk."

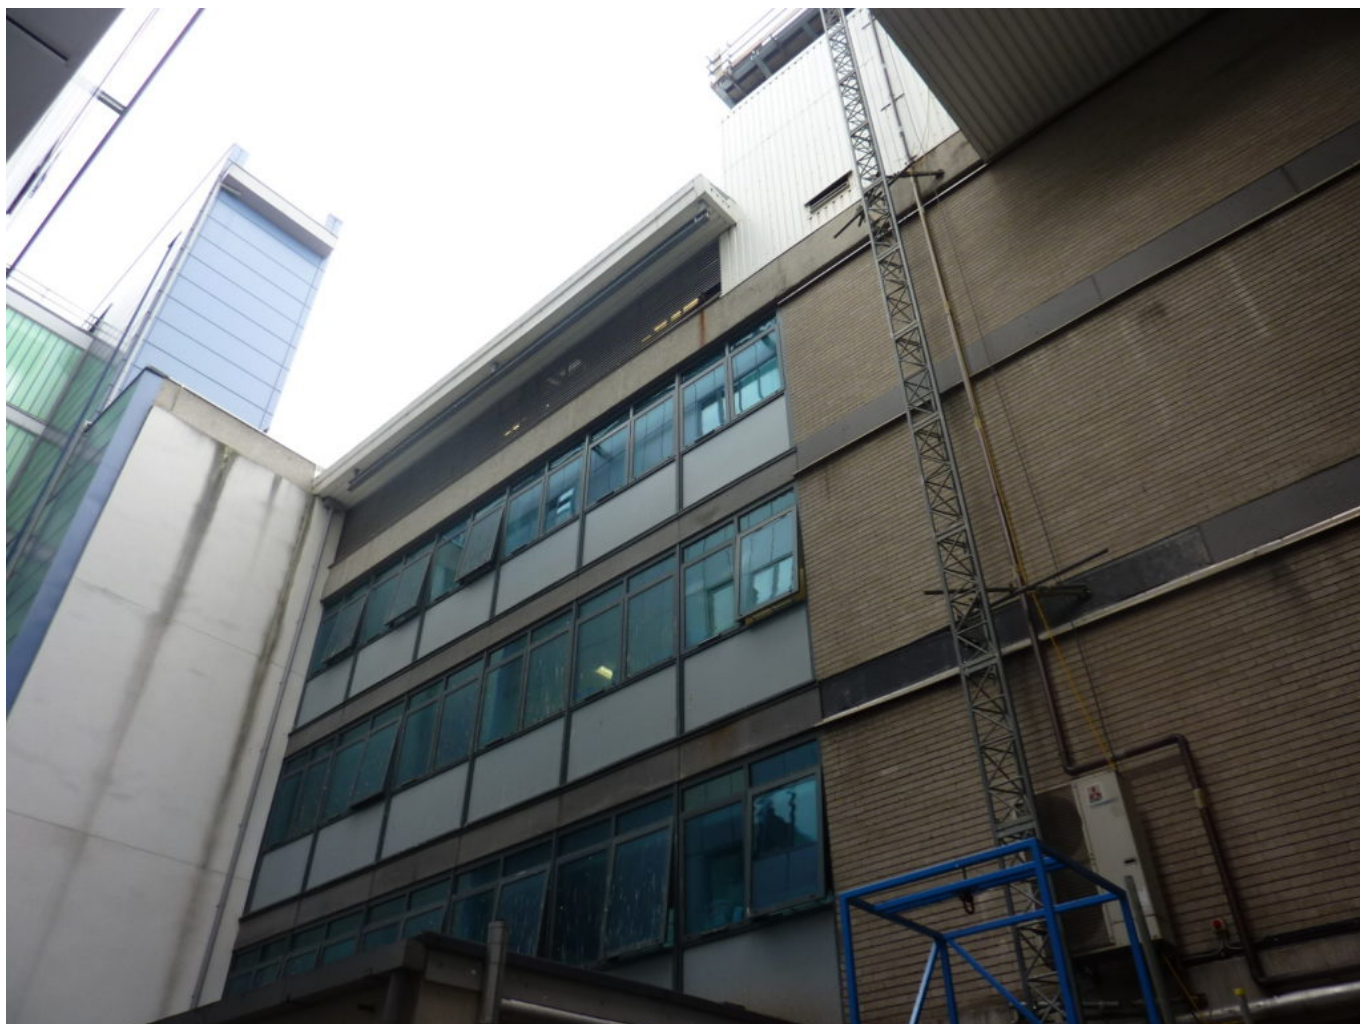
Cardiff Crown Court heard how, on 22 September 2016, Christopher Rees, employed by W D Rees Maintenance Ltd, was undertaking window cleaning at the Women's Services Unit of the University Hospital of Wales in Cardiff. Mr Rees was using suspended access equipment when he fell from the end of the beam supporting him as there was no end stop fitted, suffering significant and life-changing injuries including a broken back.

An investigation by the Health and Safety Executive (HSE) found Wayne Daniel Rees, as the director of W D Rees Maintenance Ltd, had failed to effectively plan the work at height task. He did not undertake a suitable and sufficient risk assessment or ensure that a safe system of work was in place for cleaning the windows. He made no arrangements to ensure the task was effectively supervised and also failed to ensure that there were suitable trained staff, safe equipment and a suitable rescue plan in place.

“Dutyholders must ensure that all work at height activities are properly planned, appropriately supervised and undertaken in a safe manner. It is essential that companies employing contractors do not simply rely on the knowledge and experience of the contractor but make reasonably practicable checks themselves to ensure work is safely completed.”

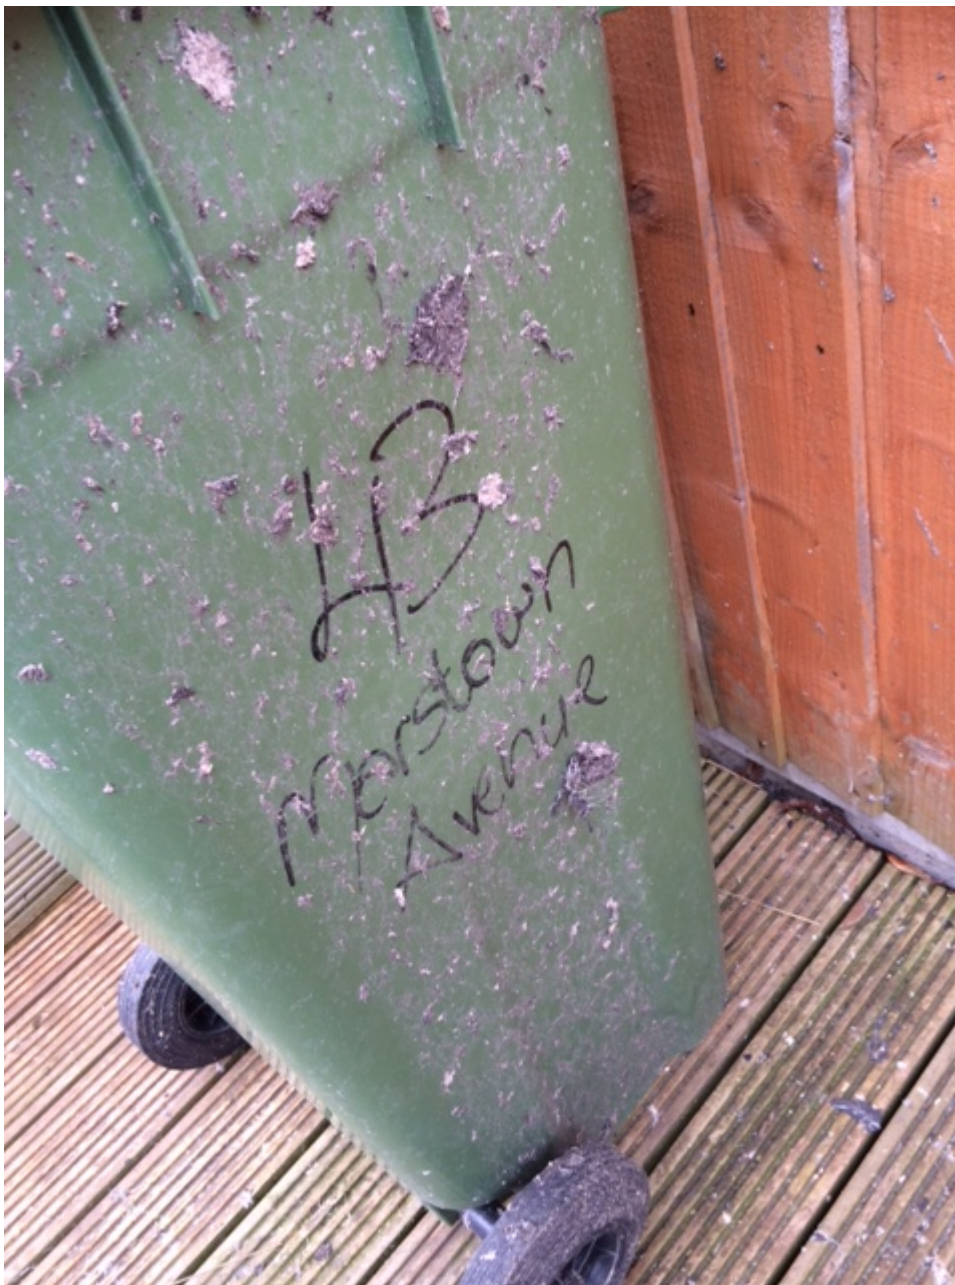
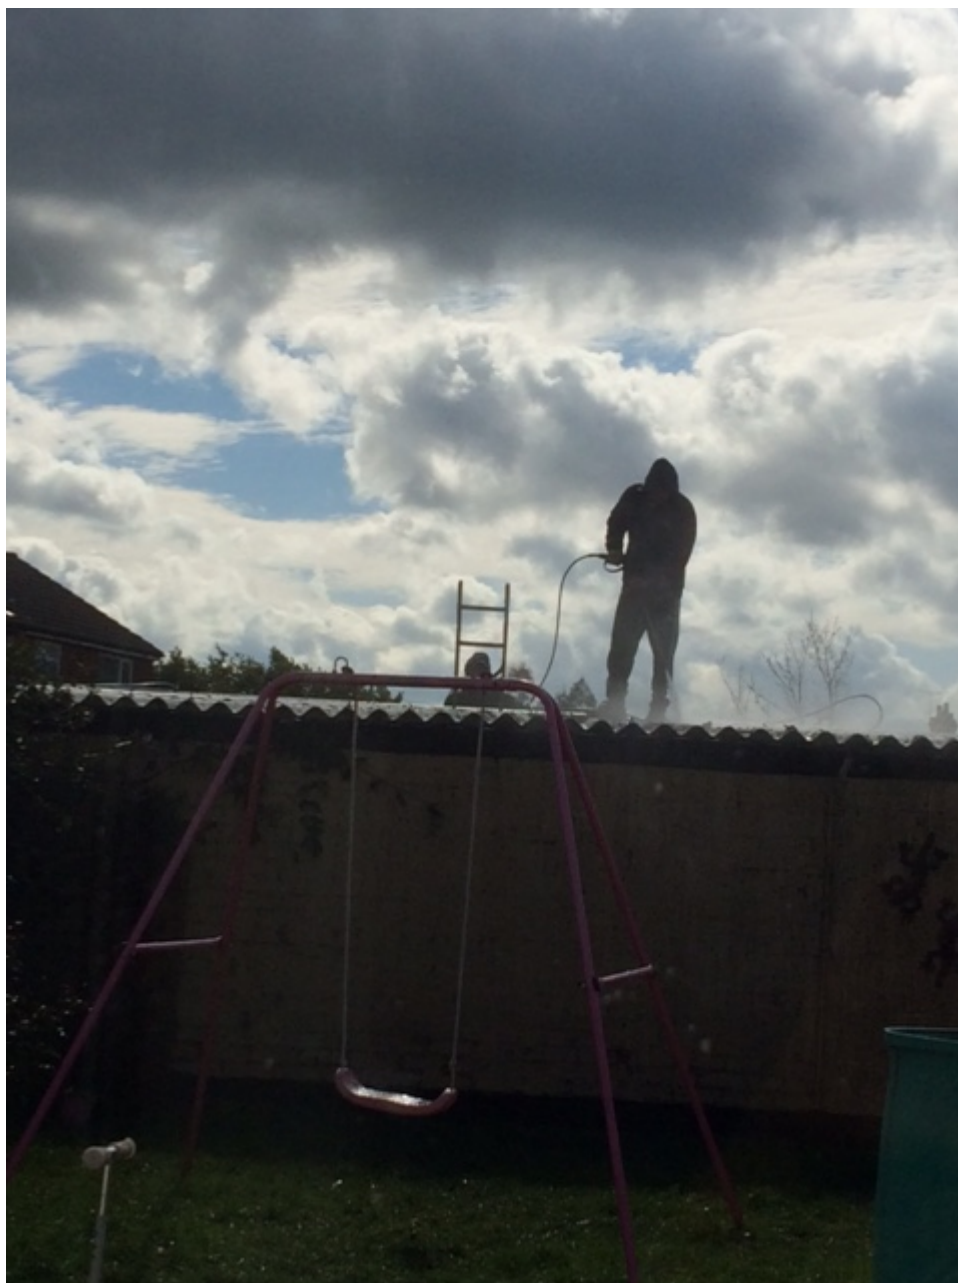
Leicester Crown Court heard that work carried out by Paul Whitaker in March and April 2016 spread asbestos over a number of domestic gardens after a powered jet-wash was used to clean asbestos cement roof sheets. The power of the water jet caused asbestos to be dislodged from the roofs, and spread across the gardens, the garage units themselves, and nearby Network Rail land. This put members of the public at risk of exposure to asbestos fibres – a Class 1 carcinogen.

An investigation by the Health and Safety Executive (HSE) found that work should have been planned to include the use of basic precautions as detailed in published and widely recognised guidance for working with asbestos cement. Low energy cleaning methods and proper protective measures would have prevented the release of asbestos fibres thus eliminating much of the risk.
