# [Report 08/2022: Collision between a tram and a cyclist, near Audenshaw tram stop](#)

RAIB has today released its report into a collision between a tram and a cyclist, near Audenshaw tram stop, Manchester, 1 September 2021.

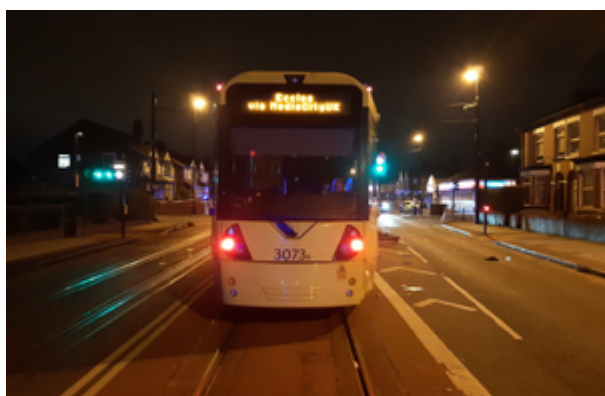
The tram involved after the accident
