# [Report 12/2022: Collision between a train and agricultural equipment at Kisby user worked crossing](#)

RAIB has today released its report into a collision between a train and agricultural equipment at Kisby user worked crossing, Cambridgeshire, 19 August 2021.

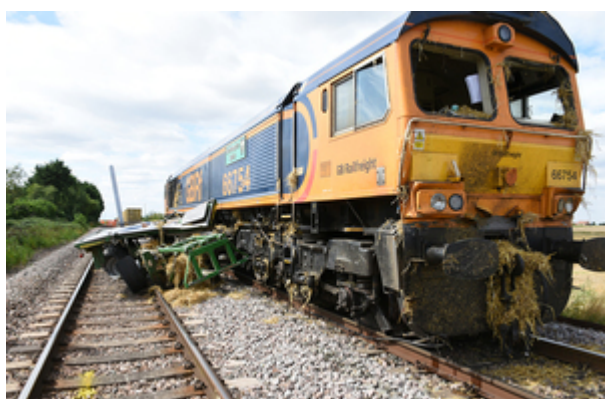
The locomotive and trailer following the accident
