# Runaway and derailment of wagons at Toton

Runaway and derailment of wagons at Toton, Nottinghamshire, 17 January 2021.

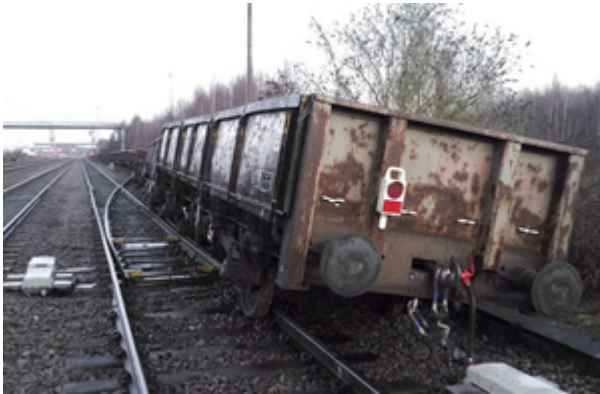
The derailed wagons at Toton South junction (courtesy of DB Cargo)

At 04:42 hrs on 17 January 2021, a rake of 22 wagons ran away from a siding within Old Bank sidings at Toton. Twenty-one wagons were loaded and the full rake had a reported weight of about 1870 tonnes.

As it ran away out of the siding, the rake passed a red signal, which generated an alarm on a signaller's workstation in the East Midlands Control Centre. This alerted the signaller, who could see that track sections along the line leading away from the exit to the sidings were being occupied. The rake then passed a second red signal and, a short distance later, the leading four wagons derailed at the end of the run-out rails associated with a set of trap points at Toton South junction. The trap points worked as intended to derail the unauthorised movement. However, the front two derailed wagons stopped foul of the adjacent running line, although no trains were nearby when the derailment occurred. The rake of wagons ran away for a total distance of about 0.5 miles (0.8 km).
