# Press release: Coal Authority calls for full consideration of legacy issues

The Coal Authority has today called for local authority planners, surveyors, developers and geotechnical and engineering consultants to ensure coal mining legacy issues are considered in light of their findings from a recent subsidence event in north-east England.

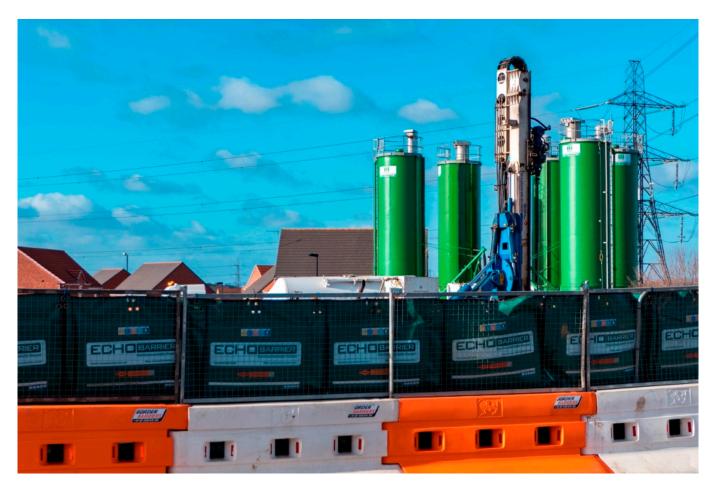
Coal Authority engineers designed a solution to stabilise the ground, and work to drill and grout the voids has been completed. Ground monitoring will continue to ensure the ground is stable for redevelopment.

This high level of extraction resulted in narrow residual supporting coal pillars and wide extraction rooms in the High Main coal seam, leading to compression on the remaining coal pillars and roof instability. This, together with a fractured sandstone layer above the coal seam, resulted in an underground collapse and subsequent movement at the surface that affected 35 properties on an estate and had an elliptical subsidence zone footprint of around 150 metres x 70 metres.
