# Contractor prosecuted due to partial collapse of building

A building contractor was prosecuted after carrying out unsafe excavation works, which resulted in the partial collapse of a residential building.

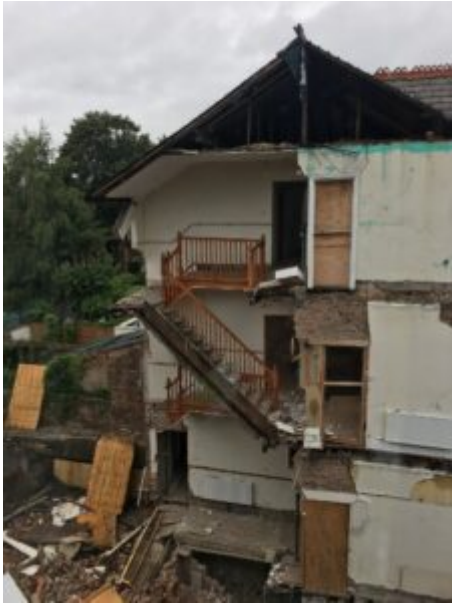
Manchester Crown Court heard how on 14 August 2019, Iproject Cheshire Limited had been carrying out refurbishment works on a building in Old Lansdowne Road, Didsbury, Manchester. Employees of the company undermined the foundations while digging out the ground around the building causing a partial collapse. There were no injuries or fatalities, but the collapse presented a risk to life.

An investigation by the Health and Safety Executive (HSE) found that the company failed to properly plan or carry out the work safely. A risk assessment into the excavations had not been carried out. There was no safe system of work in place and the work had not been sufficiently supervised.

"This incident could have been prevented if the company had carried out a suitable and sufficient risk assessment prior to commencing work on the excavations and by properly supervising the work."
