<u>Landlord of lock up garages fined for asbestos failings</u>

Restaurant owner fined after disturbance of asbestos

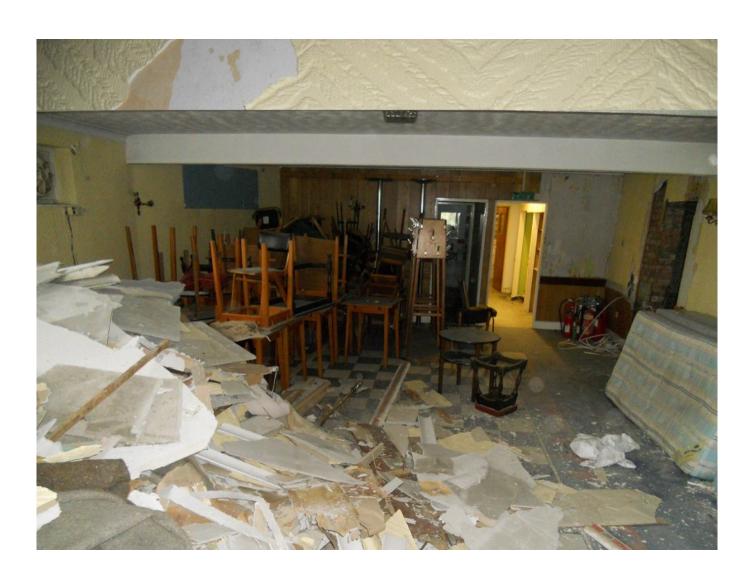
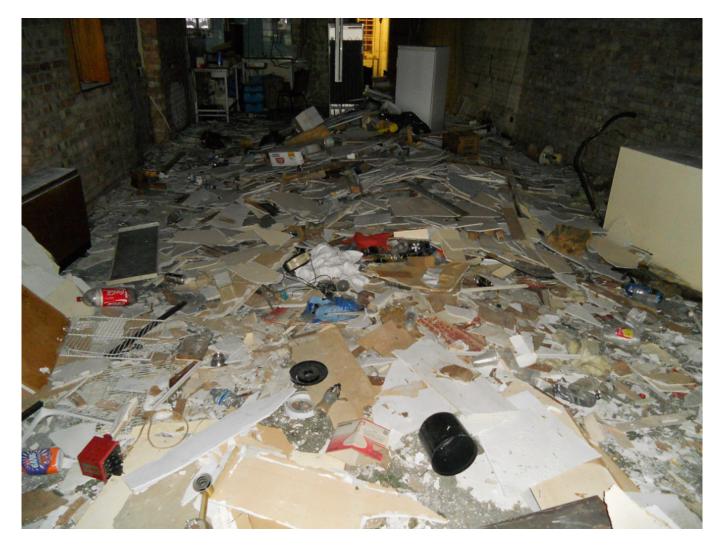
Chelmsford Magistrates' Court heard that during September 2016, above the Marco Polo restaurant on Lower Southend Road, Wickford, asbestos insulation board was removed and broken up which resulted in workers being exposed to asbestos fibres. An asbestos survey was only carried out after the asbestos had been disturbed.

An investigation by the Health and Safety Executive (HSE) found that a management asbestos survey and a refurbishment and demolition asbestos survey had not been completed prior to the work starting, and the work had not been completed by a licenced asbestos contractor.
