News story: Derailment due to a landslip at Loch Eilt

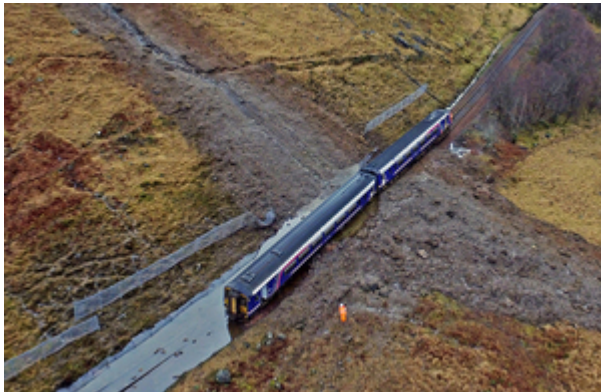
Aerial image of the landslip and derailed train

At 06:47 hrs on Monday 22 January 2018, a passenger train travelling between Mallaig and Glasgow Queen Street struck a landslip. The leading vehicle derailed and tilted to the left. There were no injuries among the five passengers and two crew on board. Passengers were evacuated to the nearest road access by a specialist rail vehicle and then transported by taxi.

The landslip was on a remote section of track between Lochailort and Glenfinnan where the line runs across sloping ground above the shore of Loch Eilt. The accident happened in darkness following a period when significant snow melt occurred at the same time as moderately heavy rainfall. The landslip originated above the railway boundary. A proportion of the several hundred tonnes of material that slipped was deposited on the railway. This destroyed a section of a fence installed recently to protect the railway from individual loose boulders rolling down the adjacent slope.
