News story: Laser technology used in works to secure mine shaft

Works are now complete to secure an unrecorded mine shaft, which caused a ground collapse at Kilbowie Road, Clydebank.

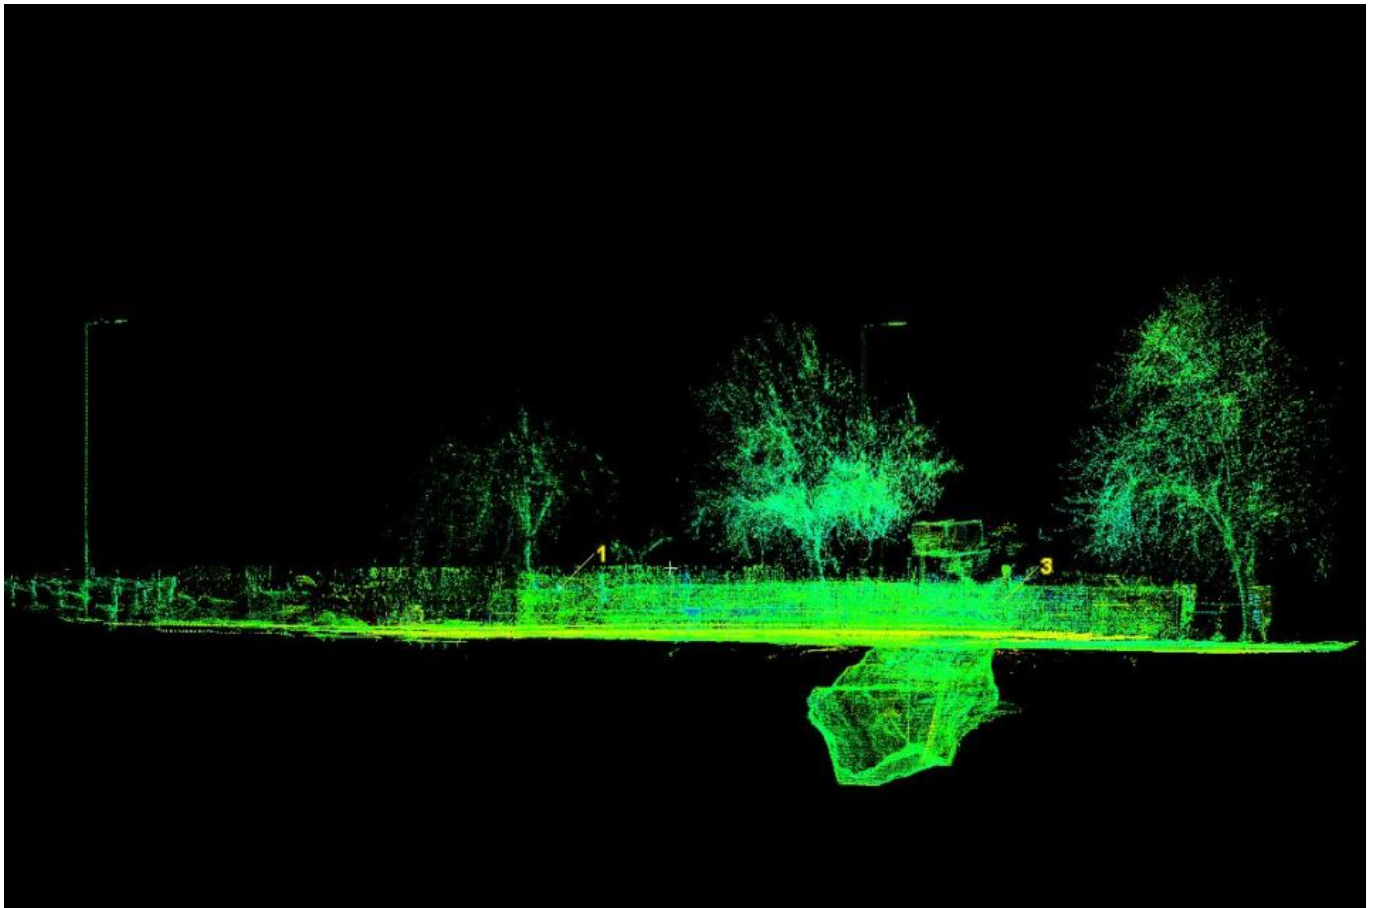
While only a 6 metre diameter hole was initially visible at the surface, investigations using laser scanning technology identified this led to a 200 cubic metre void on top of the unrecorded mine shaft, which went down a further 56 metres.

Laser scan showing the void beneath Kilbowie Road

- fill the shaft with 140 tonnes of stone and inject 217 tonnes of pressurised grout
- construct a reinforced concrete cap
