News story: Laser technology used in works to secure mine shaft

Works are now complete to secure an unrecorded mine shaft, which caused a ground collapse at Kilbowie Road, Clydebank.

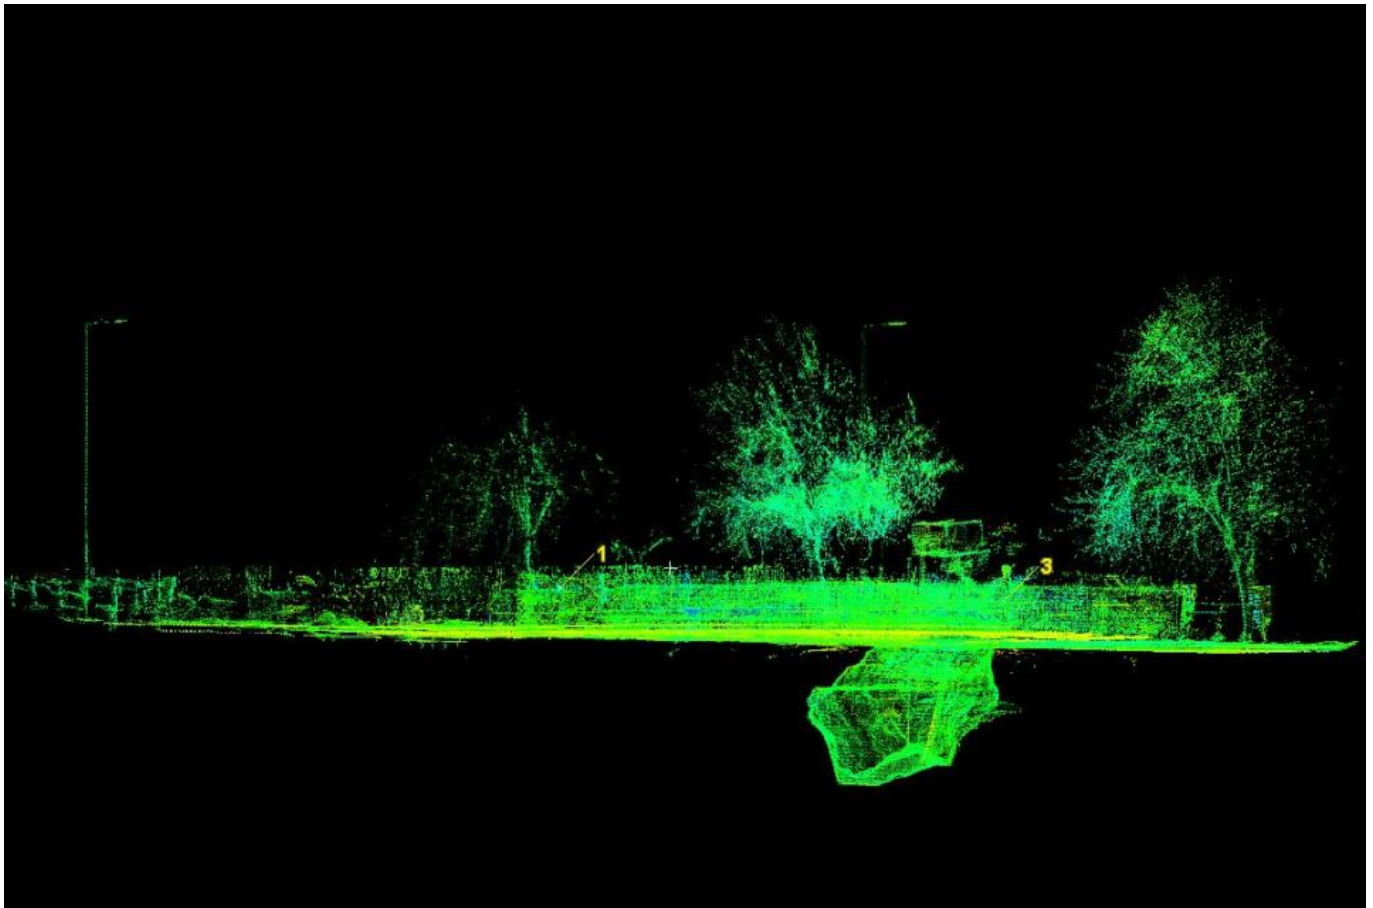
The collapse was caused by a mine shaft that was not detailed in historical mining records, but we believe that it was used to extract coal, limestone and iron ore over 100 years ago.

While only a 6 metre diameter hole was initially visible at the surface, investigations using laser scanning technology identified this led to a 200 cubic metre void on top of the unrecorded mine shaft, which went down a further 56 metres.

Laser scan showing the void beneath Kilbowie Road

- fill the shaft with 140 tonnes of stone and inject 217 tonnes of pressurised grout
- construct a reinforced concrete cap

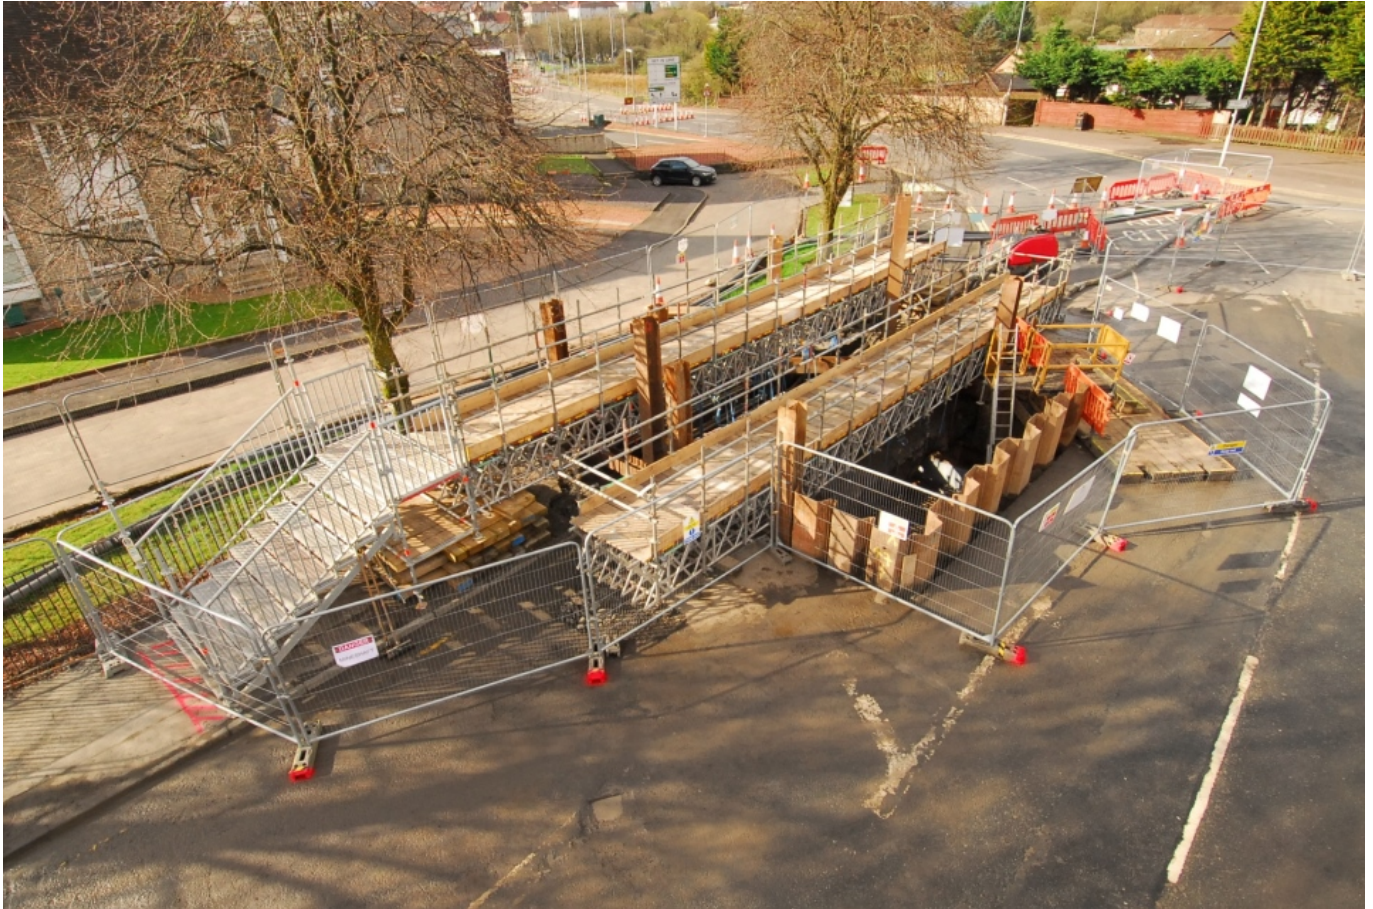
This repair was further complicated by exposed utility services in the void that needed to be protected during the works. A fractured foul water sewer and storm water drain within the ground collapse also made the repair more complex, with water needing to be pumped over 150 metres around the void during the works.

The Coal Authority's works at Kilbowie Road, Clydebank
