Offshore companies fined after grandfather injured on North Sea gangway

The Health and Safety Executive (HSE) prosecuted Shell and Ampelmann Operations following the incident off the Norfolk coast on 17 October 2017.

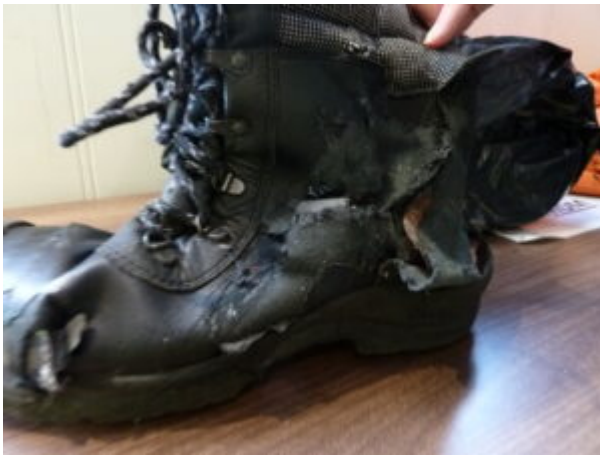
The damaged boot Mr Hill had been wearing at the time of the incident

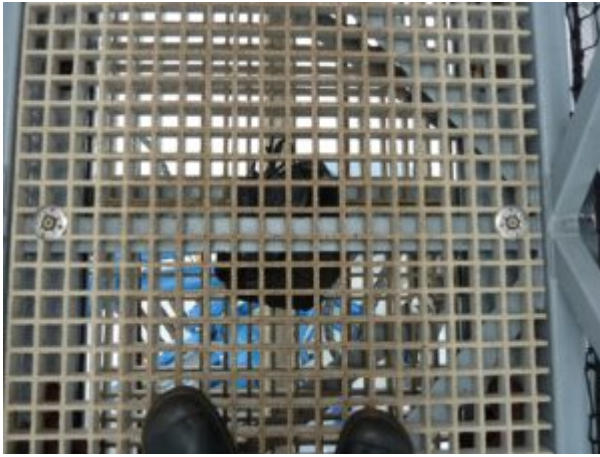
As Mr Hill made his way along gangway from the support vessel towards the rig, he did so in the pre-sunrise gloom. Although there was some artificial lighting, there was not enough of it in the right places. Both of his feet got trapped as the gangway telescoped together. The serious nature of the injuries meant he had to be airlifted to hospital and he narrowly avoided having both of his feet amputated.

Mr Hill's trapped boot in the gangway

The HSE investigation found that people using the Ampelmann-designed and owned gangway were not sufficiently protected from the risks of entrapment and trip injury at the moving step. Ampelmann simply failed to take all reasonably practicable steps to reduce the risk of people's feet being trapped at the sliding step. Mr. Justice Jeremy Johnson said that, though some efforts were made, "There were some basic errors which persisted over a long time".

Mr. Justice Johnson said of Shell's instructions to the staff conducting transfers "were inconsistent and confusing and spread across several documents. They were not understood by those operating" the gangway transfer system. In addition, Shell also failed to ensure that lighting was in accordance with long-standing guidance available on the HSE website: <https://www.hse.gov.uk/pubns/books/hsg38.htm>. Mr Justice Johnson said in assessing Shell's culpability, "The problems were in place for a considerable time and were far from minor or isolated".
