# Pothole repairs – Dunmore Gardens

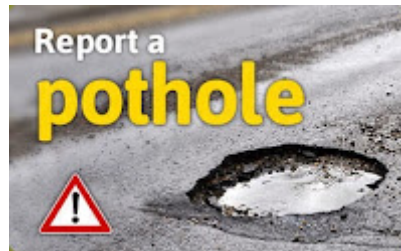
**'The repairs were inspected and I note that these pothole repairs do not have a film of bond coat painted on the existing road surface prior to filling which will affect the long term adhesion and therefore durability, and I will take this matter up internally.'**

**The material specified for use in carriageway pothole repairs is chosen to suit a depth of 40mm, or greater. By trying to carry out a repair to a defect of insufficient depth the material sits proud and fretts at the edges as the aggregate within the material cannot fit in the depression once compacted. If we use smaller aggregate then there is insufficient strength in the material to resist expected vehicular loading.**

The road surface is in poor shape and I have made the point that the road needs resurfacing far earlier than this – I will continue to press this matter.
