Property owner sentenced after builder suffered life changing injuries

A Derbyshire property owner has been given a community order after a father-of-two sustained life changing injuries when a wall collapsed on top of him during a barn conversion.

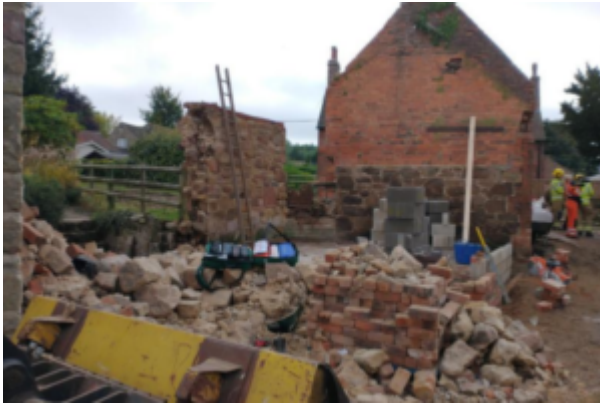
Derby Magistrates Court heard how the building had undergone significant structural alterations. It was while Mr Tyson was clearing up outside, that the external face of the stone gable wall collapsed on top of him causing

life threatening injuries.

The site where the wall collapsed in Woodhouses, Derbyshire

An investigation by the Health and Safety Executive (HSE) found that Nigel Edwards had failed to have a structural assessment of the outbuildings undertaken prior to starting the work. As a result, no measures had been identified or implemented to stabilise the building while underwent the alteration. Similarly, there was no plan in place for dismantling parts of the building safely, exposing workers and members of the public to the risk of injury or death from the full or partial collapse of the structures.

Speaking after the hearing, HSE inspector Robert Gidman said: "It is vital that all demolition and dismantling is adequately planned and that a competent structural engineer is engaged by those in control of work where there is the risk of collapse of any structure.

"If this project had been planned effectively, engaging the right people at the right time to ensure a suitable safe system of work was implemented, the life changing injuries sustained by the injured person could have been prevented."
