[Report 08/2022: Collision between a tram and a cyclist, near Audenshaw tram stop](#)

RAIB has today released its report into a collision between a tram and a cyclist, near Audenshaw tram stop, Manchester, 1 September 2021.

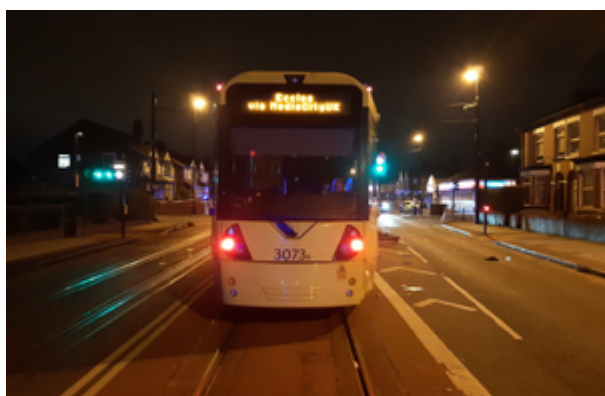
The tram involved after the accident
