River Aire flood defences are winter ready as work continues on permanent repairs

Press release

Permanent repairs to flood embankments on the lower River Aire are underway after they were damaged during storms last winter.

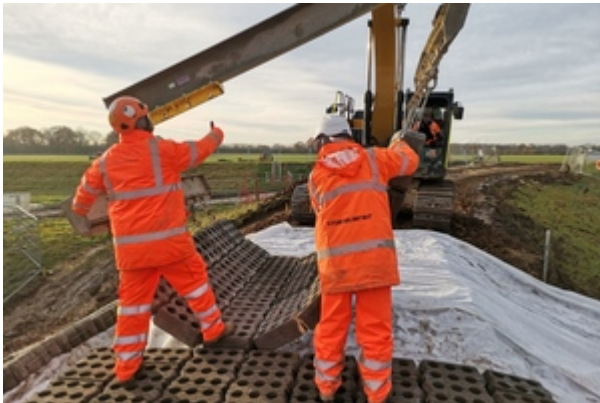
Reinforcing the embankment at Poor Bank

The latest repairs are being completed at Pick Hill embankment near Snaith and Poor Bank embankment near Gowdall where concrete blocks are being installed to make them more resilient to future scour damage if a similar flood was to happen again.
